Manhole Inspection Summary

Manhole # S51K__045MH

Inspection ☐ Is Incomplete Rating: **3) Fair**

Insp Date: **4/1/08 8:10 AM**

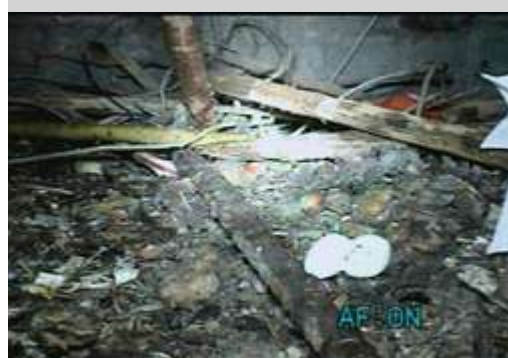
Defect 4

infiltration from street level

channel debris

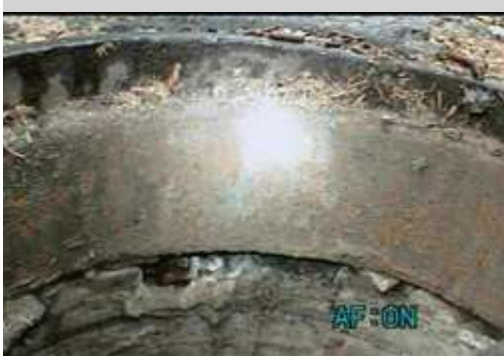
Defect 3

Condition: ☐ Sound ☐ Cracked ☐ Root Intrusion ☐ Loose Brick ☒ **Deteriorated**

deteriorated, fractures in corbel

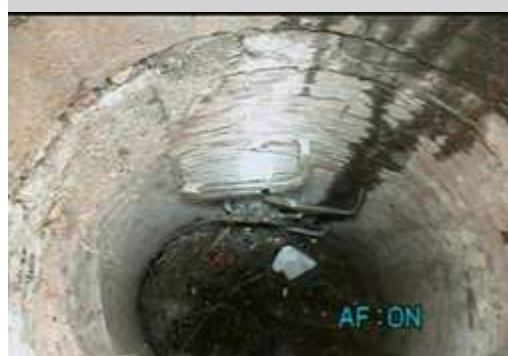
Defect 1

Count: **4** Missing: **0** ☒ **Corroded**

Steps

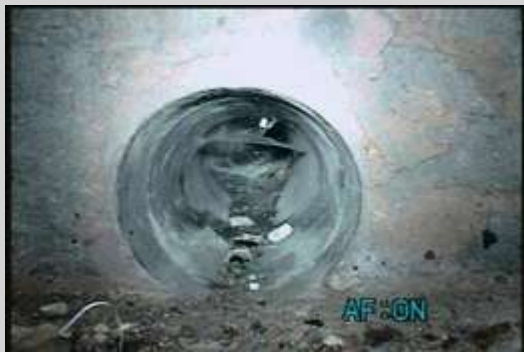
12 O'Clock Outflow

8 in. Circular Gravity Sewer
Pipe Out @ 12 O'Clock
